May 2, 2002
Job No. 2-817-003935

Re: Report
Supplemental Geotechnical Study
The Cedars at Cedar Hills, Plat E Phases 1 - 5
East of State Road 146 at Approximately 10500 North
Cedar Hills, Utah

**THE CEDARS TOWNHOMES
 LANDSLIDE MITIGATION PLAN**

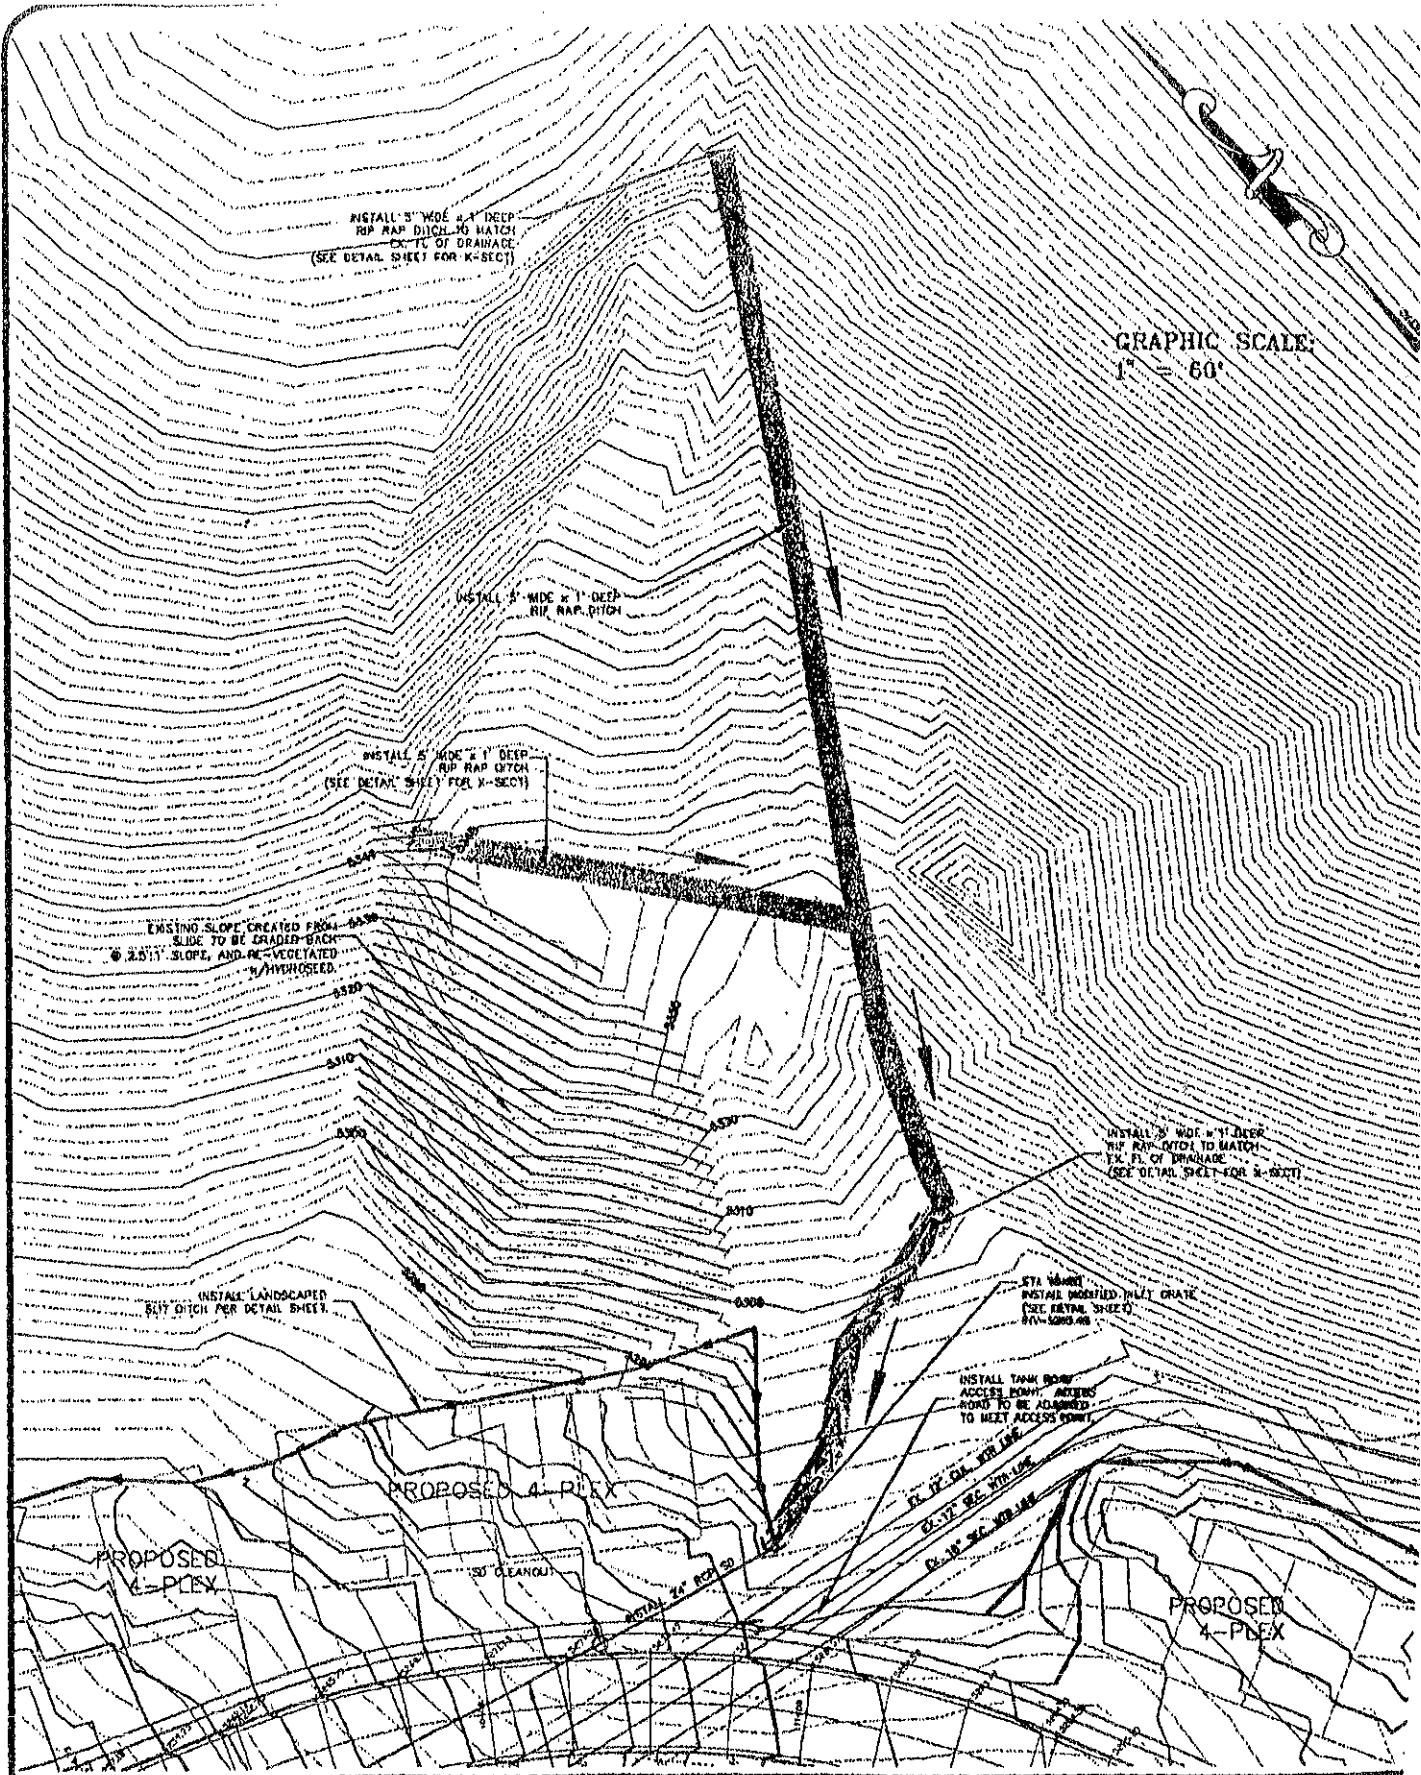
The second component of the overall 1983 slide/slump occurred just northeast of the proposed Building 4 location and in our opinion was triggered by extensive erosion/undercutting of the steep southeast-facing slope of the drainage. This slope consisted of the ancient landslide materials. The other side of the drainage is dominated by bedrock which is exposed in the channel. During the periods of excessively high rainfall, we not only had the undercutting of the old landslide deposits but saturation of these deposits. This led to the slide/slump which essentially terminated about six feet up-gradient of the east-center portion of proposed Building 4. As typical of these slide masses, the area near the crest is hummocky with numerous depressions which do not allow for fast and efficient pass through of runoff waters down the drainage. Although there is no evidence of any significant movement since 1983, ponding of water in these depressions above the runout point is not beneficial to the overall stability of the runout soil mass.

Based upon results of this supplemental study, it is our opinion that by proper grading and drainage improvements, the stability of the presently stable lower 1983 slide mass can be increased sufficiently to allow for the construction of Building 4. Remediation efforts that will be required must consist of:

1. The improvement of the drainage within the lower slide/slump mass by regarding the closed depressions so that ponding of water in the slide/slump mass does not occur

2. Facilitate and rapidly discharge surface water down the natural drainage in a manner that it will not undercut the steep southeast-facing slope forming the northwest boundary of slide/slump mass. Specifically, the primary drainage channel will be along the southern portion of the slide/slump mass against the natural bedrock slope. A secondary rip-raped ditch will be constructed in a generally northwest-to-southeast direction through a depression in the middle of the slide/slump mass. The drainage will discharge to the previously discussed primary ditch. A sketch of this concept is attached. In conjunction with installation of the rip-raped ditches, regrading will take place as to minimize any closed depressions and facilitating fast runoff of any surface water to the ditches. The primary purpose of this drainage improvement is to reduce the possibility of water infiltration in the lower portion of the slide mass.

3. Cut the toe of the slide/slump mass back at a slope no steeper than two and one-half horizontal to one vertical. The toe of the final slope should be at least 8 to 10 feet back of Building 4. The present slope in areas is approximately one and one-half horizontal to one vertical and during periods of extremely heavy precipitation could be susceptible to fairly shallow slumping and/or mud flow type failure. The excavated materials can be re-utilized as structural site grading fill in the mass grading operations.

When the above operations have been completed, it essential that the surface soil in the regraded slide/slump mass be appropriately revegetated or otherwise protected against erosion.
